Rapportage
Archeologische
Monumentenzorg

A Swedish man-of-war in Dutch waters

*An archaeological field evaluation of the wreck
of the Sophia Albertina*

A.B.M. Overmeer

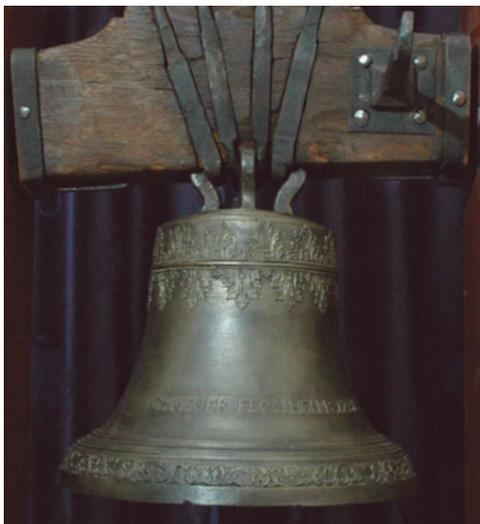
Illustration 2a: The ship's bell bearing the legend G:MEIJER FEC:IHOLM: 1738 (photograph: A. Vos, RCE, thanks to H. Raven). Whole image.

The bronze ship's bell, together with its wooden belfry, was brought to the surface, where the following text was revealed: 'G:MEIJER FEC: IHOLM: 1738'. The other side featured a cartouche

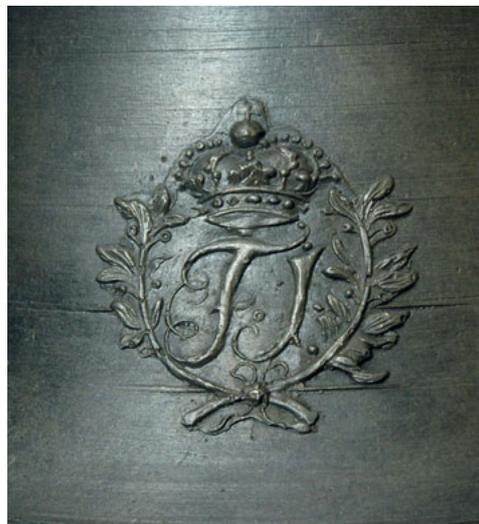
Illustration 2b: Detail of cartouche of laurel branches surrounding the letters FI or FJ topped by a crown (photograph: A. Vos, RCE, thanks to H. Raven)

of laurel branches surrounding the letters FI or FJ topped by a crown (illustration 2). Raven made enquiries at the National Maritime Museum in Stockholm and was told that the bell had been made by Stockholm founder Gerhard Meyer. In view of the royal crown on the bell and the number of cannons at the site, Swedish researchers suspected that the ship was a Swedish man-of-war, probably the Princess Sophia Albertina, a ship of the line that sank off Den Helder on 20 August 1781 (Appendix 3). Raven contacted the Netherlands Institute for Ship and Underwater Archaeology (NISA) about the conservation of the wooden belfry, and was advised to have the object treated by controlled drying.⁸

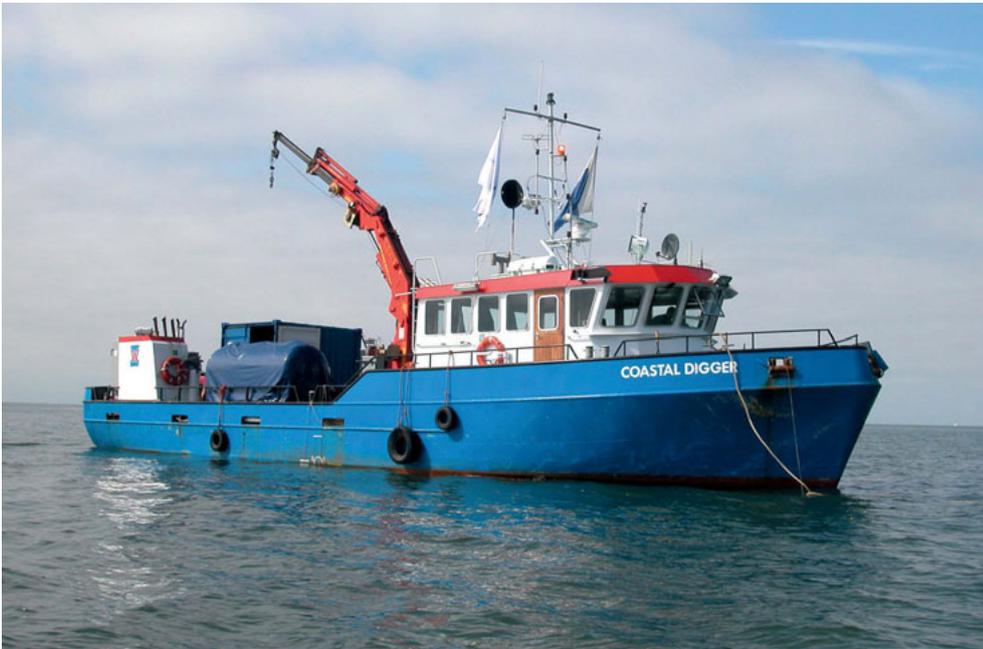
Illustration 6: The Coastal Digger in action during the 2004 fieldwork (photograph: H. Schraal. RCE).

A boat was hired for the fieldwork from Rederij Waterweg BV in Den Helder, now part of the firm Acta Marine. This boat, the Coastal Digger, was 23.05 by 6.15 m, with a draught of 0.9 m.¹³ It was equipped with a 35-tonne crane and had a spacious working deck and wheelhouse, making it an ideal support base for the archaeological work (illustration 6). A 10-foot container (to store diving gear and serve as a changing room for the divers) and a decompression tank were placed on board specifically for the diving work (illustration 7). Under the provisions of the Working Conditions Act ('Working in a pressurised environment'), a decompression tank must be available on-site for diving depths in excess of 15 m.

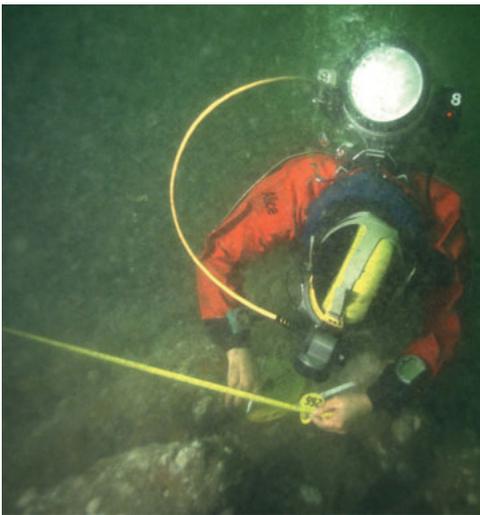
Illustration 12: Diver Alice Overmeer measuring distances between the datum points (photograph: R. Aarsen, NOB).

The divers then used a measuring tape to establish the distances between the underwater datum points (illustration 12). These distances and depths were entered into Web-it, a computer program specially developed for underwater archaeology. Web-it precisely calculates and maps the relative positions of all measuring points. This results in a file showing file showing the relative locations

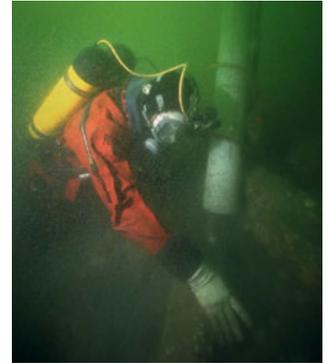
Illustration 11: Diver Peter Leensen working with the airlift (photograph: R. Aarsen, NOB).

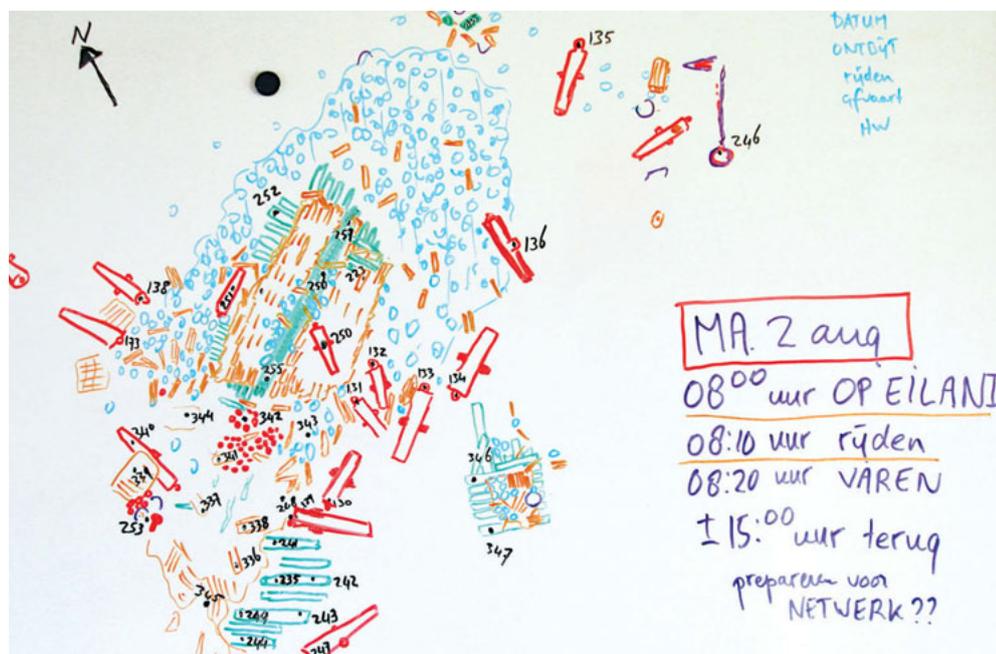
Illustration 14: Overall site plan of the Noorderhaaks 10 shipwreck during fieldwork (photograph: A. Vos, RCE).

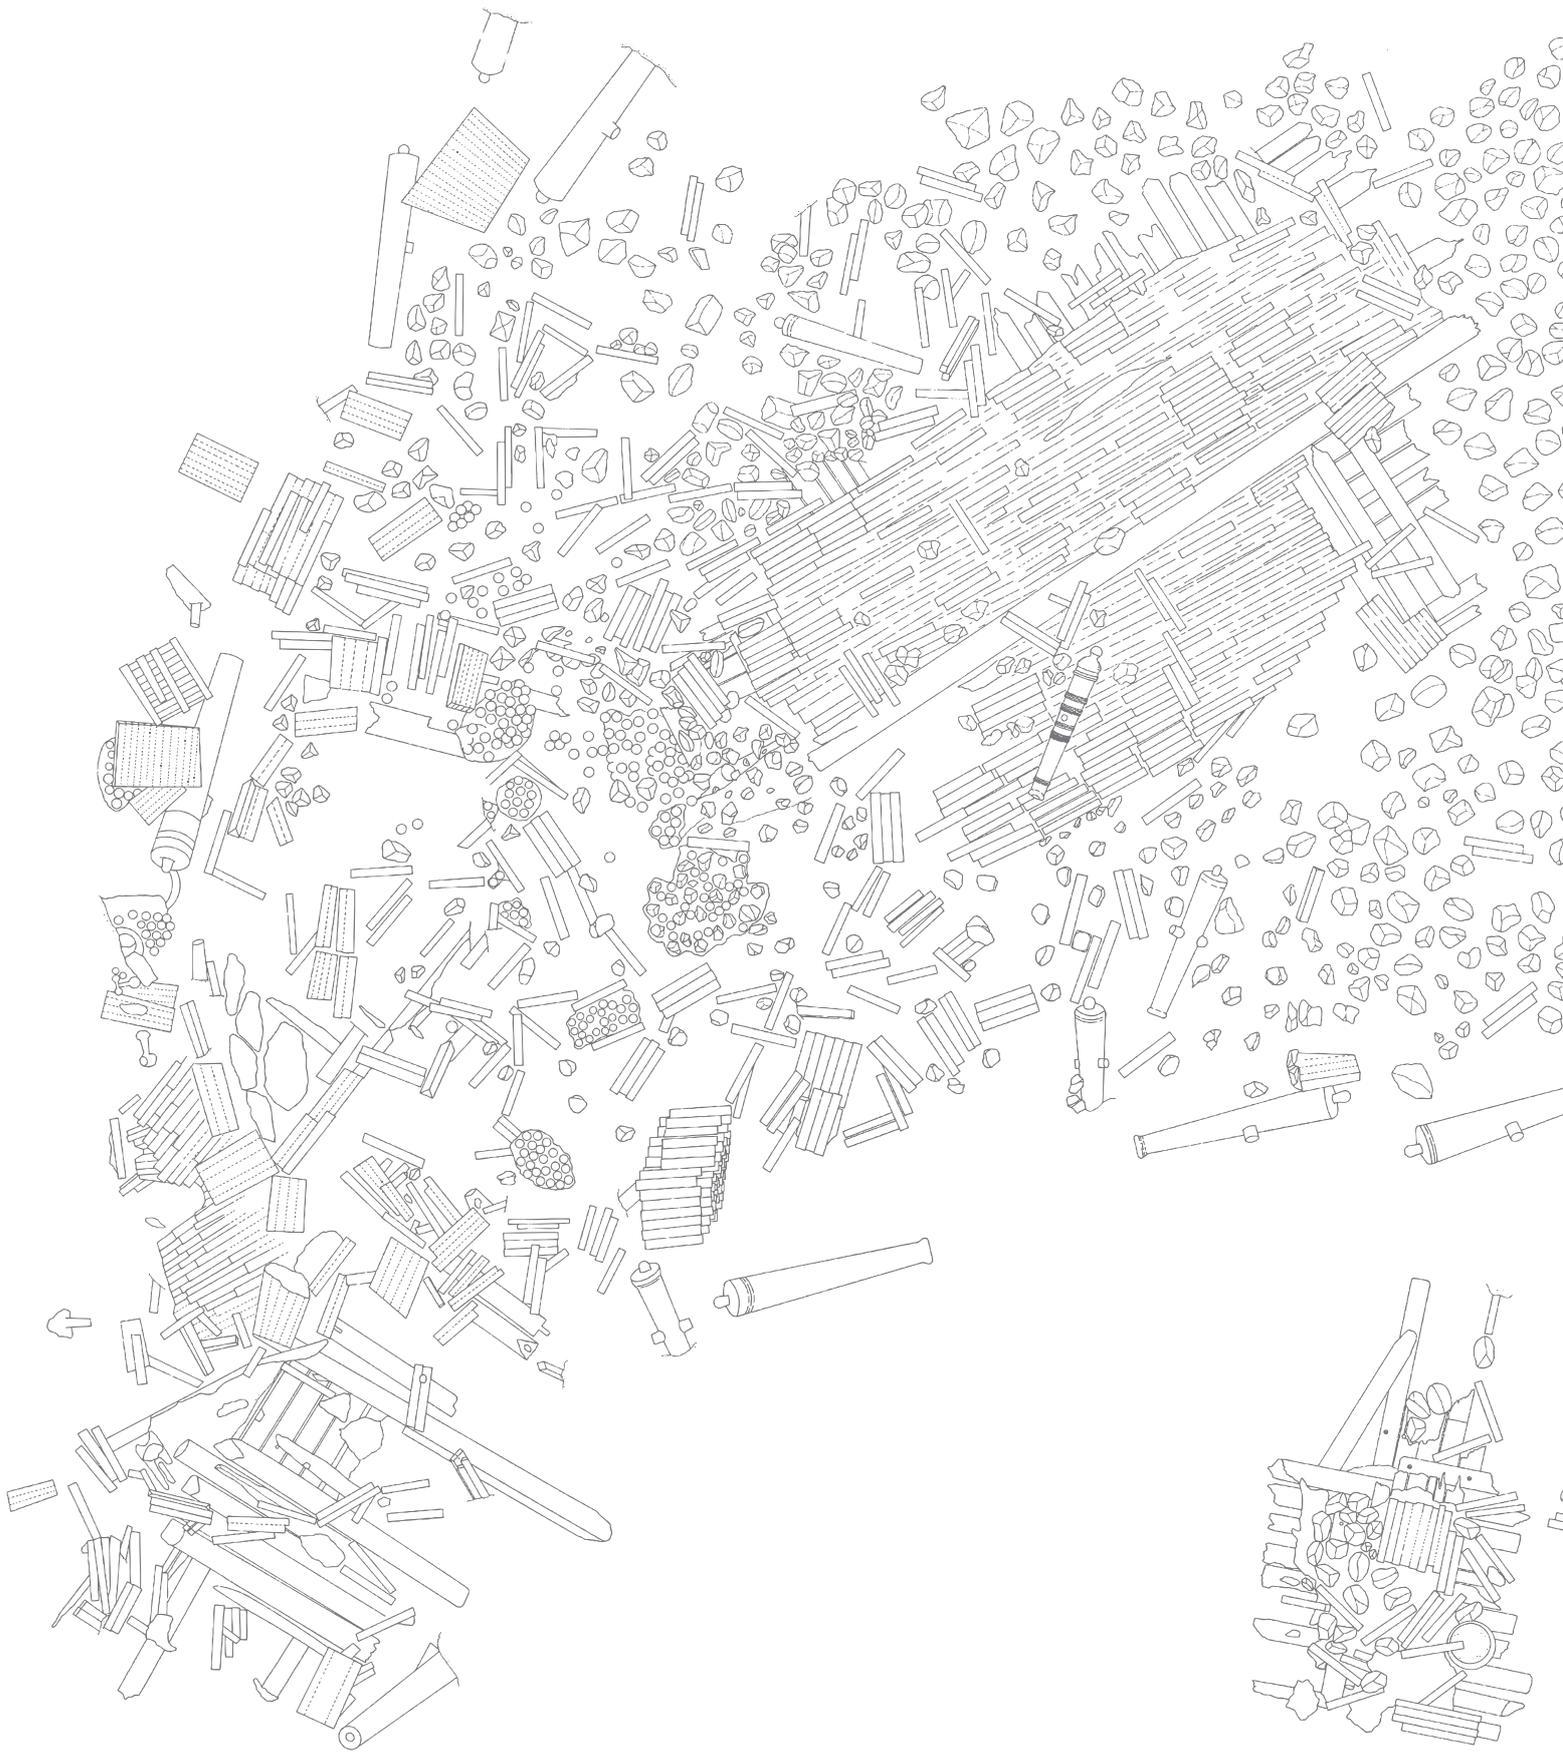
SOPHIA ALBERTINA.
Overzichtstekening
get. E. van Gent
datum mei 2005

and cannonballs encrusted together. Only sporadically is the ship's structure found in association. A second fragment of the ship measuring 8 by 6 m lies in the southern part of the site. It does not appear to be associated with the ship's structure under the platform of iron, but this has not been established with any certainty. This fragment is part of the ship's bottom that is broken at the turn of the bilge. It lies upside down; the eleven heavy floor timbers have been tapered on the western side to form a scarf joint and they display a slight curvature on the underside (see also section 4.2.4). Beneath the floor timbers are seven ceiling planks, the planking from the inside of the ship.

Illustration 20: Overall site plan of the Sophia Albertina (drawn by E. van Gent, RCE)

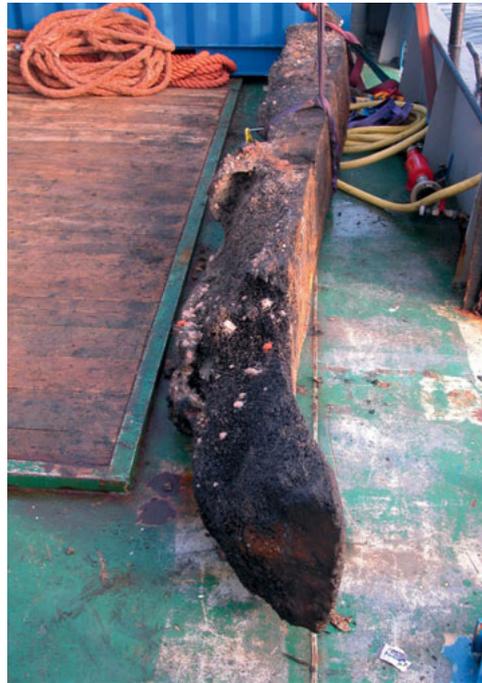
Illustration 22: Recovered floor timber SA-10 with datum points 242 and 335 (only the latter is still attached). The curvature representing the turn of the bilge can still be clearly seen (photograph: H. Schraal, RCE).

to the underside, which is also the most degraded side (illustration 22).

This is therefore a fragment of the ship's bottom that is broken at the bilge. The framing timbers are 27 to 38 cm wide and thick. Most are 3 to 5 m long, and the recovered timber is no less than 6 m long.

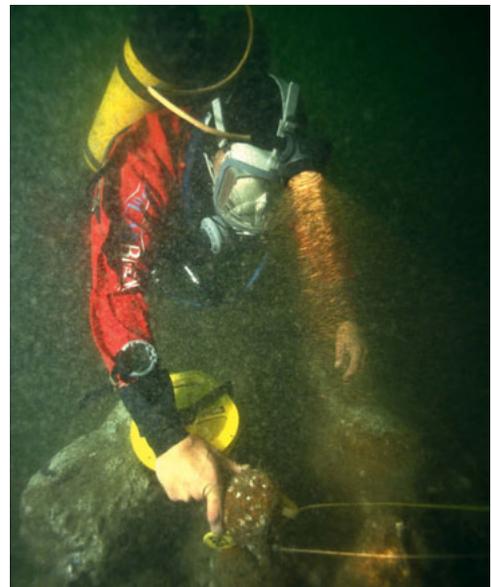
Illustration 23: Diver Frank Koppen by a piece of bar shot to which datum point 253 has been attached (photograph: R. Aarsen, NOB).

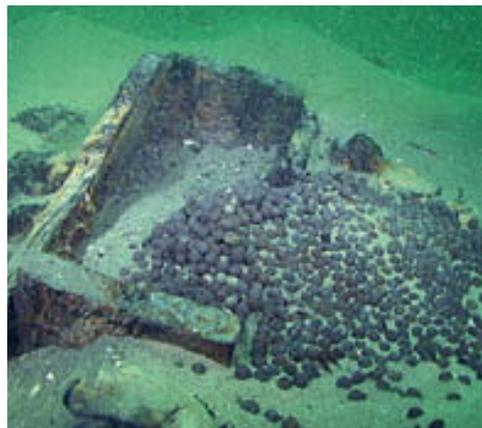
Illustration 25: The munitions chest under water (photograph: P. Leensen, RCE).

they succeeded in locating it once again on 28 July (illustration 27). It was then recovered and assigned find numbers SA-46 and SA-47.²⁴ The chest measures 50 by 22.5 by 21.5 cm. It is constructed of softwood planks 2.5 to 3.5 cm thick that are nailed together. The chest lay at an angle in the seabed, with one side missing. The lid is still present and, at 55 cm, is slightly

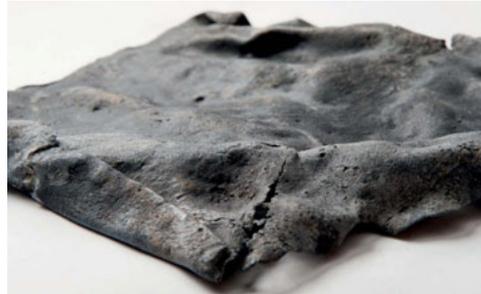
Illustration 31: Lead plate SA-57 (photograph: R. Schipper).

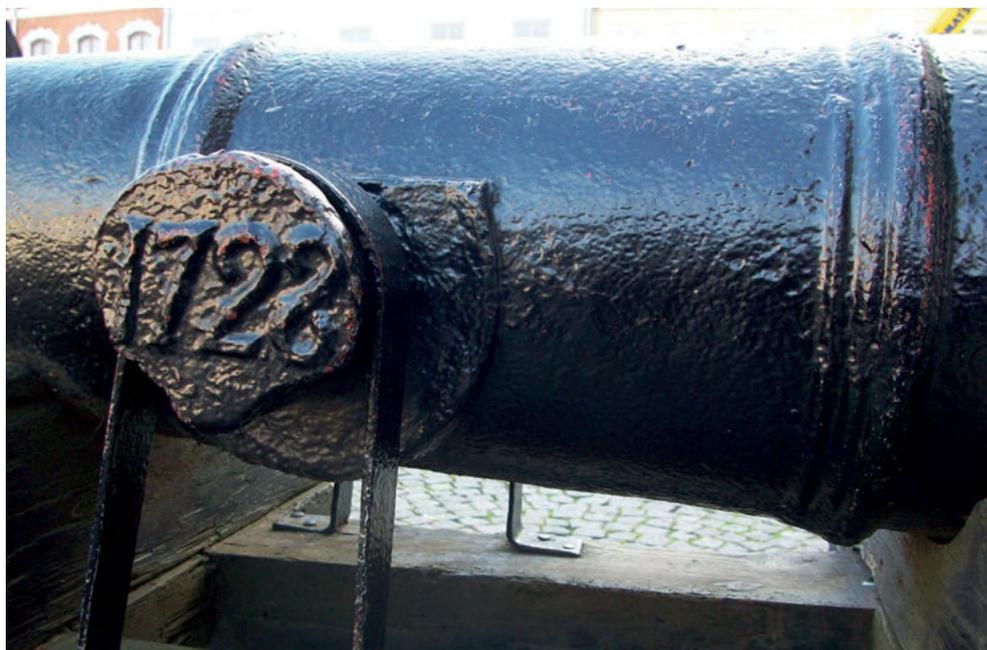
Illustration 35: Example of a cannon with trunnion shoulders and the year mark 1728, not found at Noorderhaaks 10/Sophia Albertina (photograph: N. Brinck)

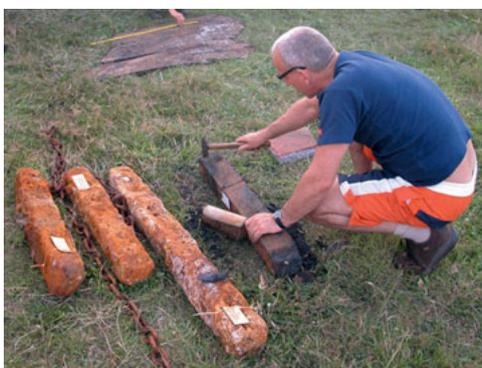
Illustration 44: Head of the diving team Arent Vos attempting to remove the concrete from an iron bar (photograph: H. Schraal, RCE).

After being heated, the bars were measured and weighed. SA-13 is 78 by 10 by 8 cm and weighs 31 kg; SA-14 is 78 by 10 by 10 cm and weighs 41 kg; and SA-54 measures 90 by 12 by 11 cm and weighs 43 kg. SA-12, which was not annealed, measures 120 by 9.5 by 9.5 cm in its concretised state. The bar was not weighed, but its dimensions would suggest a weight of about 60 kg.

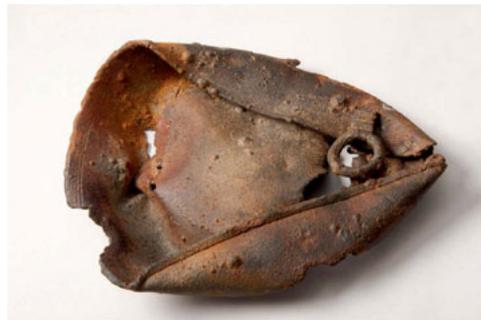
Illustration 45: Flattened tin pan or cauldron SA-4 (photograph: R. Schipper).

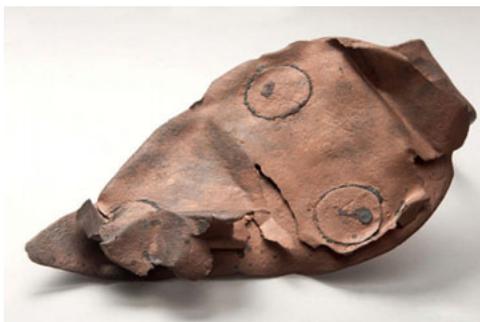
Illustration 47: Large copper handle from copper cauldron (photograph: R. Schipper).

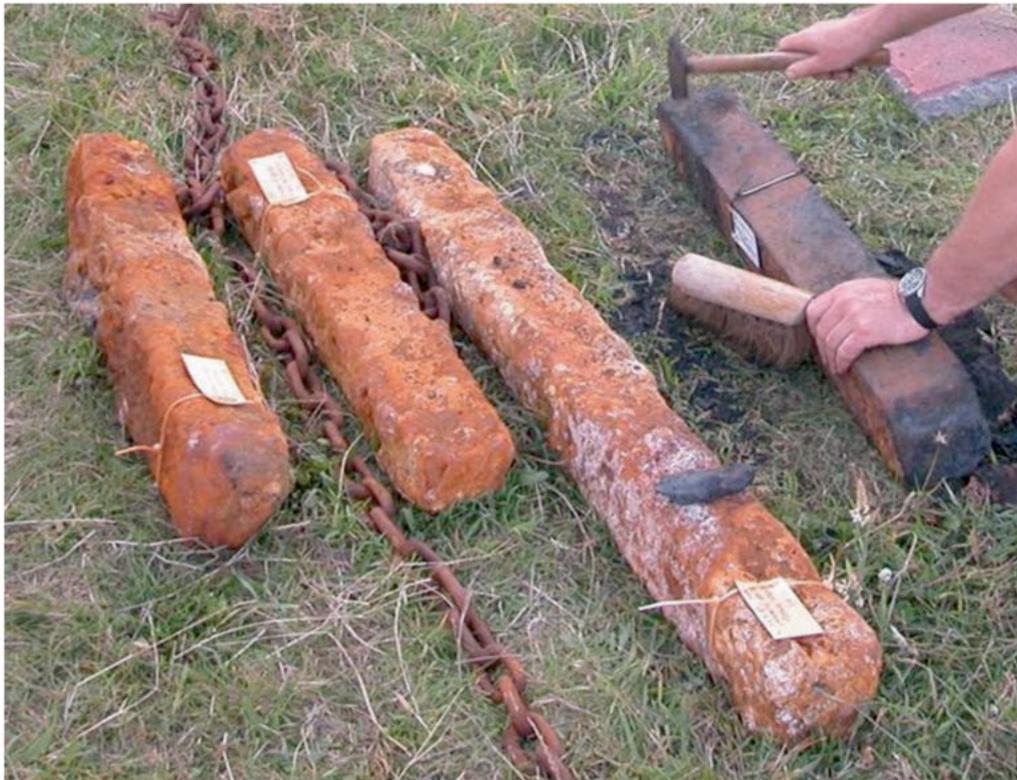
Foto 1) De ijzerbaren, zoals ze eruitzagen na berging: met een laagje concrete. Ofschoon de concrete redelijk loskwam, ging dat toch niet 100% zonder beschadiging van het object, dus is verder gekozen voor gloeien.

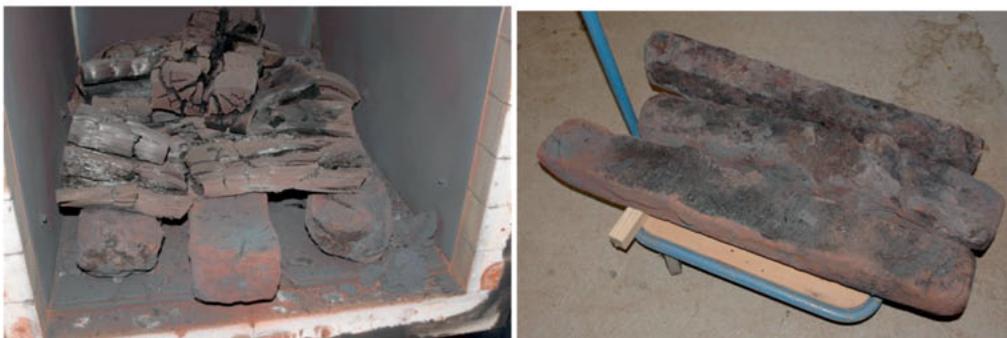
Foto 2, links) Het ijzer en hout direkt na opening van de oven. Het hout is verkoold, maar niet verast.

Foto 3, rechts) De ijzerbaren vóór de eerste, oppervlakkige schoonmaak: een ruw uiterlijk, hier en daar een rode kleuring, barsten en sporen houtskool

Om een reducerend (zuurstofarm/-loos) milieu te krijgen en om een medium te creëren, waarin vrijgekomen chlorides zouden kunnen neerslaan, is een ruime portie hout meegestookt. Na opening van de oven was al het hout volkomen verkoold, maar totaal niet ver-ast. Hieruit leiden we af, dat er in ieder geval geen vuur is geweest: het hout is niet verbrand. Het hout was ook totaal niet wit uitgeslagen, waaruit we afleiden, dat er blijkbaar weinig chlorides in zijn neergeslagen. Mogelijk betekent dit, dat er nauwelijks

chlorides in het ijzer zaten. Ofschoon eerdere ervaring (namelijk dat aanwezige chlorides wit neerslaan in het houtskool) deze conclusie lijkt te rechtvaardigen, willen we dat toch nog een keer expliciet vaststellen middels een proef met ijzer, dat zeker nog chlorides bevat.

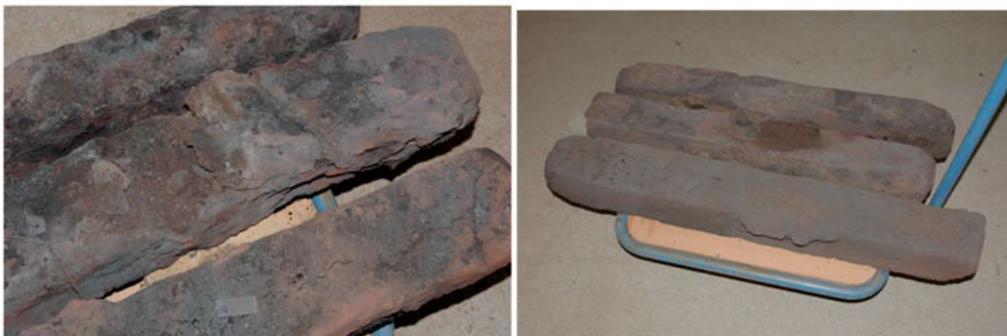
Foto 4, links) Detail van het ruwe oppervlak na het stoken.

Foto 5, rechts) De baren ná het stralen. De rood-kleurende laag blijkt voornamelijk oppervlakkig en het ijzer heeft veeleer een donkergrijze kleur. Is dit origineel oppervlak met hamerslag, of toch nog een laagje concretie, dat eraf gestraald kan?

De eerste indruk van het ijzer was, dat er mogelijk toch ietsje zuurstof bij is geweest en dat het oppervlak (voorzover zichtbaar tussen of onder de concretie) enigszins is verbrand; het vertoont namelijk "hamerslag".¹ De concretie, die niet erg dik blijkt, was op het eerste gezicht niet zo goed langs het originele oppervlak losgekomen als eigenlijk verwacht en er vertoonden zich een paar scheuren, die (diep) in het ijzer leken door te lopen.

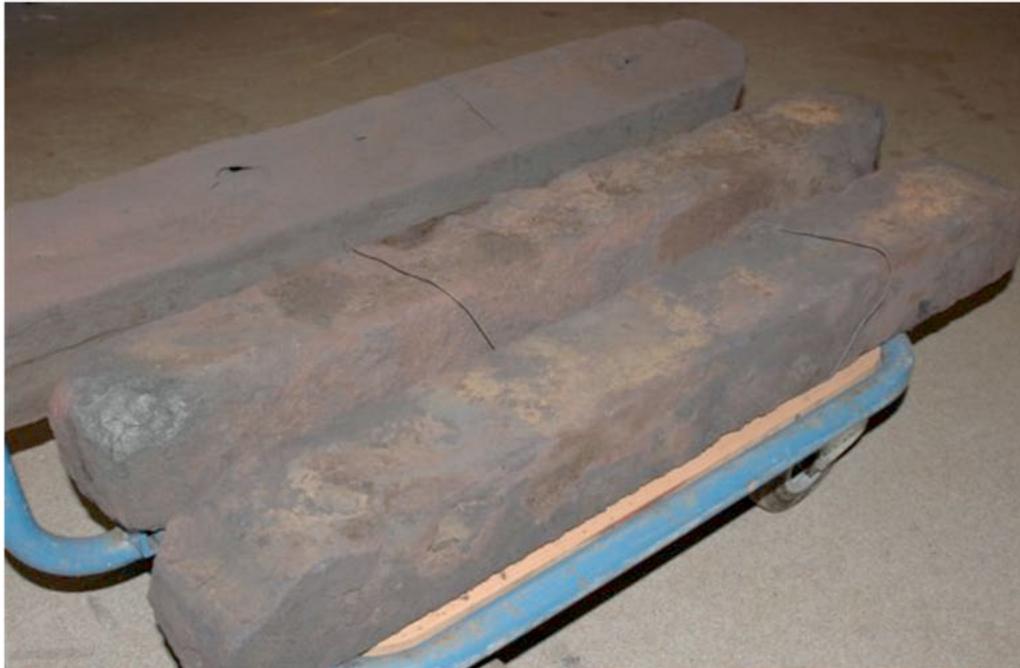
Foto 6) De baren na het stralen. Het ijzer is donkergrijs met nog slechts een dun laagje, dat iets rood tekent.

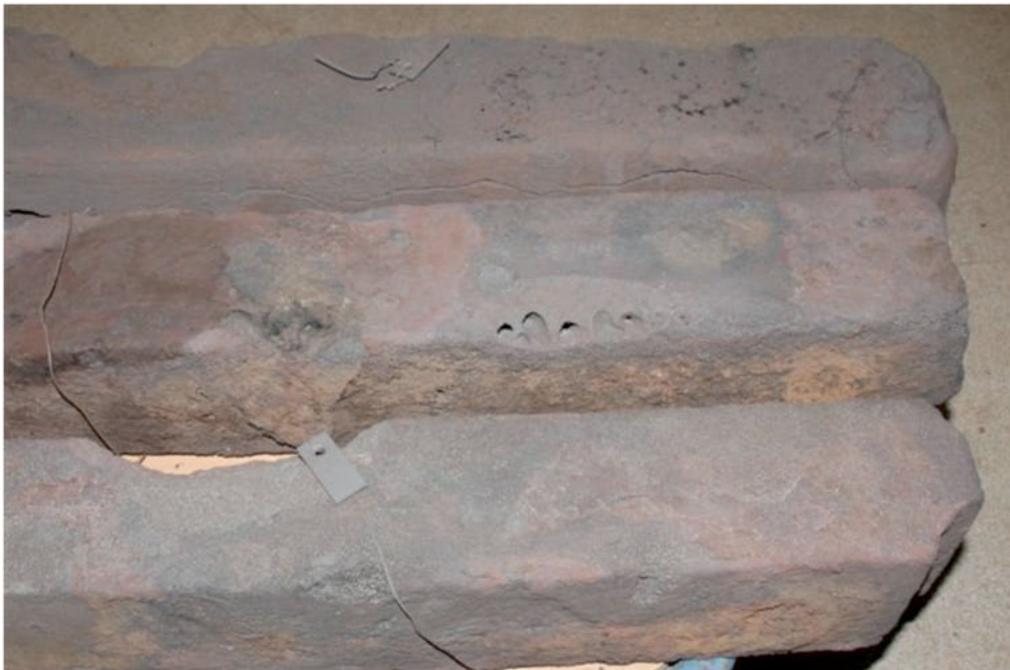
Foto 7) Detailopname van het schoongemaakte en (licht) gestraalde ijzer. De vorm is vrij strak, maar met hier en daar gietblazen, uitgebrande holtes van waarschijnlijk voormalige insluitingen en uitstulpingen van het gieten. Let op de aan de onderkant aangebrachte uitsparingen als handvatten. Deze zijn op alle baren aanwezig.
